**Flood Control Project Maintenance
Levee Inspections
LMA District Cover Sheet
Spring 2010 Levee Inspection Results**

Spring 2010 Levee Inspection Results

Waterway			Bank	Unit Miles
Unit No. 01 Right Bank Cache Creek			Right	0.29
	Spring (March - May)	Summer (June - August)	(September - November) Fall	Winter (December - February)
Unit Maintenance Rating (Fall Only)				
Date of Inspection	3/30/2010 - 3/30/2010			
DWR Inspector	John Williamson			
Accompanied By

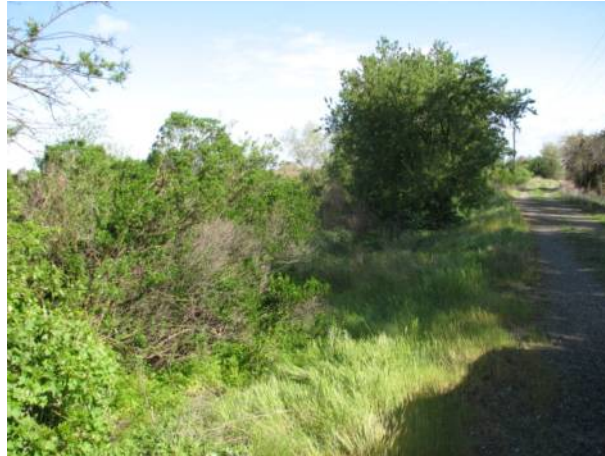
Levee Mile Report Line	3
Start Levee Mile	0.01
End Levee Mile	0.13
Location	Water Side
Category	Earthen Levee
Item	Vegetation
brush on water side	
johnngw_s_20100401_087.jpg

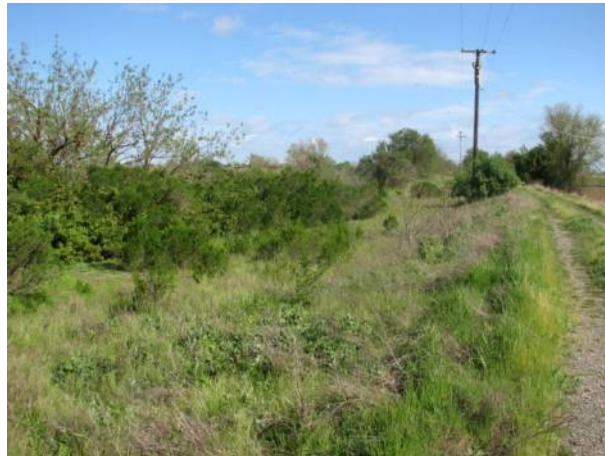
Levee Mile Report Line	3
Start Levee Mile	0.01
End Levee Mile	0.13
Location	Water Side
Category	Earthen Levee
Item	Vegetation
brush on water side	
johnngw_s_20100401_089.jpg

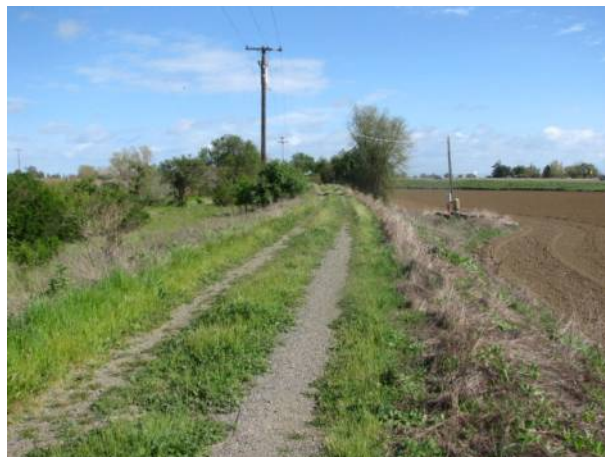
Levee Mile Report Line	4
Start Levee Mile	0.02
End Levee Mile	0.29
Location	Crown
Category	Earthen Levee
Item	Vegetation
vegetation on crown	
johnngw_s_20100401_088.jpg
